QUARTERLY JOURNAL OF INFORMATION

Issue Q4.14

THREAD GALLING AND STAINLESS STEEL THREADED FASTENERS

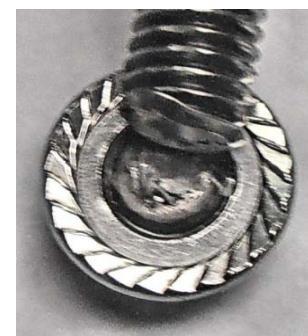
Sometimes fasteners have a problem in loosening and separating from mating parts. This condition is called thread galling. This is a friction weld process created during installation of the part with mating surfaces. The galling process during installation is particularly susceptible to stainless steel fasteners. During installation, tightening of mating parts build pressure between the contacting surfaces and breaks down the protective oxides causing the high points to lock together.

Galling can be minor causing only slight damage to the threaded surface. In severe cases, it can completely weld the nut and bolt together and prevent the removal of the fastener. Often times, during installation the threads may strip out or the fastener may twist off. Galling is more likely to occur when the external threads are cut, rather than rolled. Cut threads have rougher surfaces due to the machining process. Galling can also result from surface oxidation in some materials.
